CGS Post-Earthquake Field Data Collection for the 2022 Ferndale & 2024 Cape Mendocino Earthquakes, Humboldt County, California

Brian Olson
Senior Engineering Geologist
California Geological Survey

Cascading Hazards Workshop
March 7, 2025 – Newport, OR

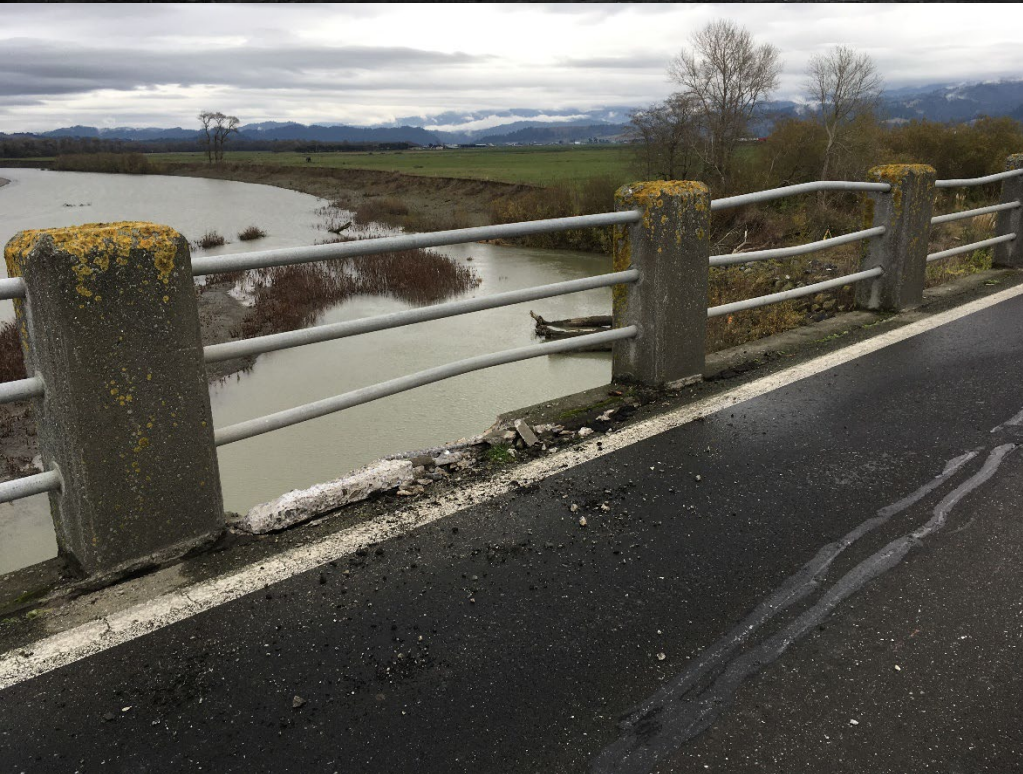
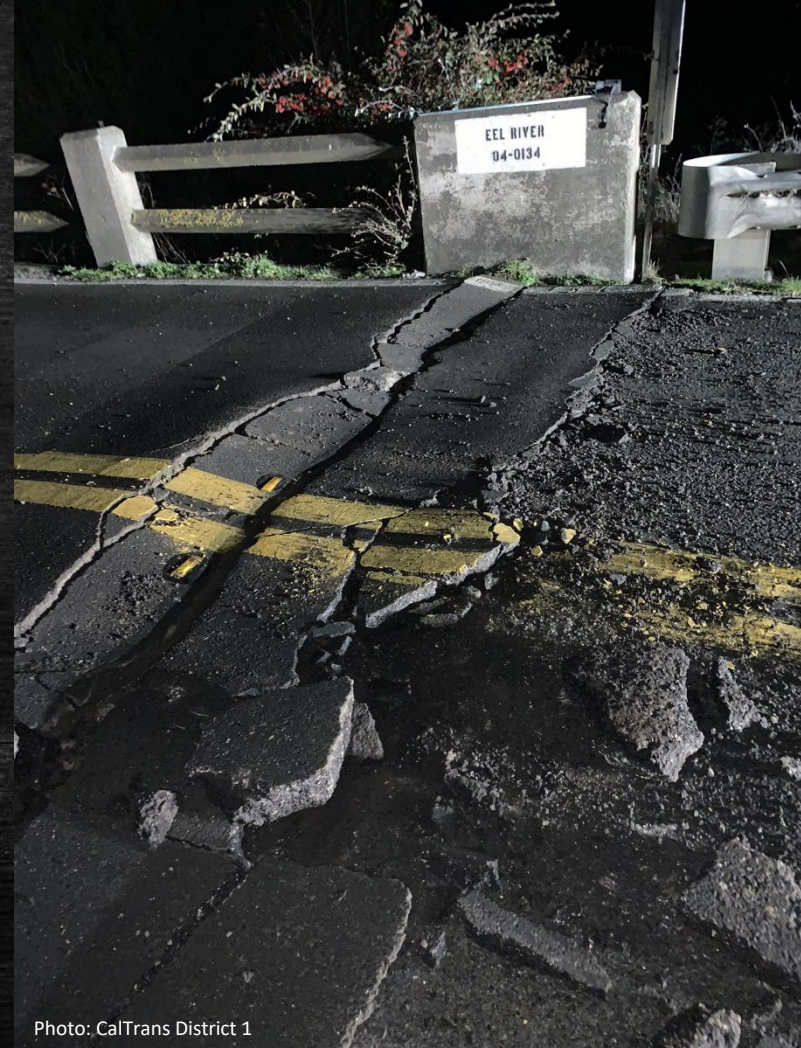
Fernbridge – built 1911

Closed for 24 hours

Nearby stations recorded PGAs ranging from 0.26g – 0.30g

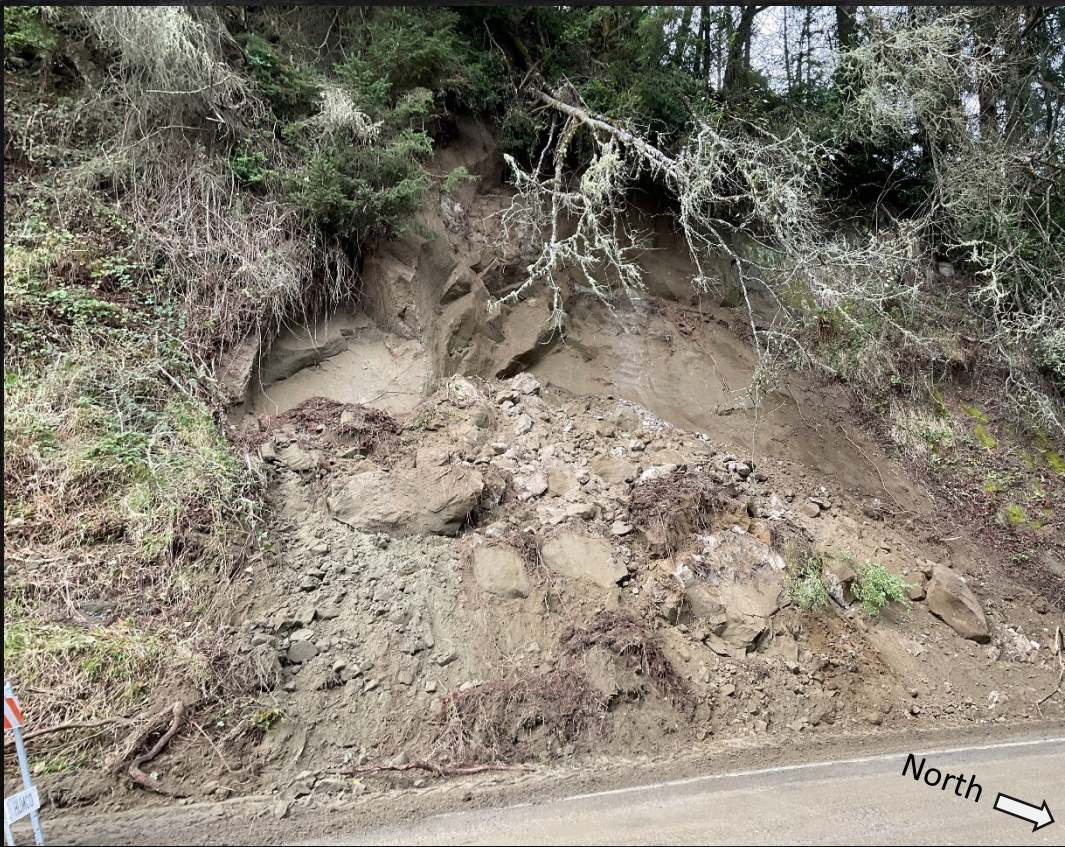
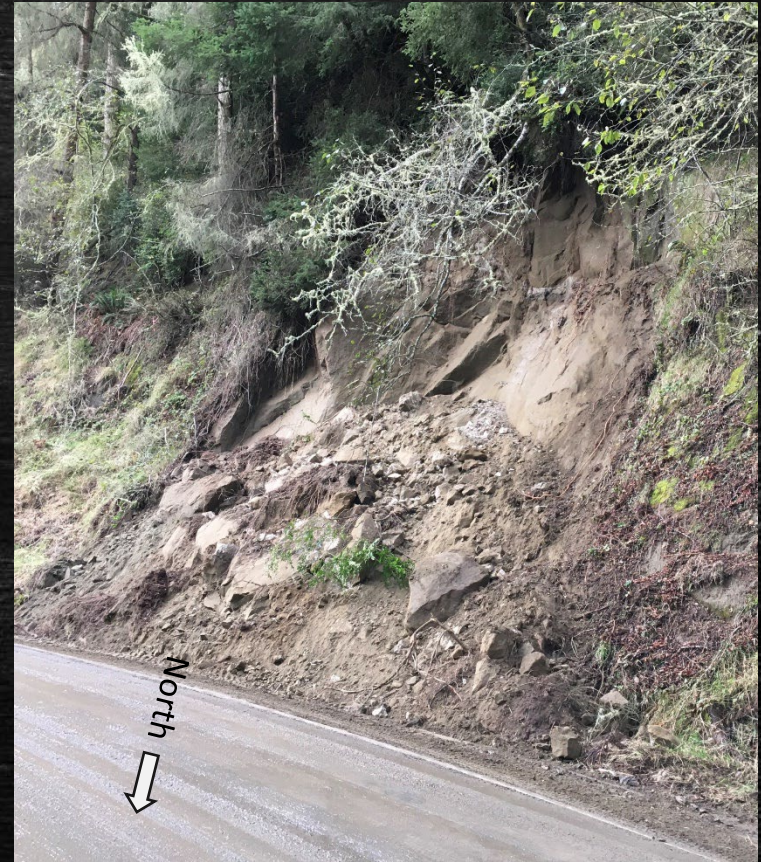
**Mattole Road
(south of Ferndale)
Road cut landslides**

Nearby stations
recorded PGAs of
about 0.12g

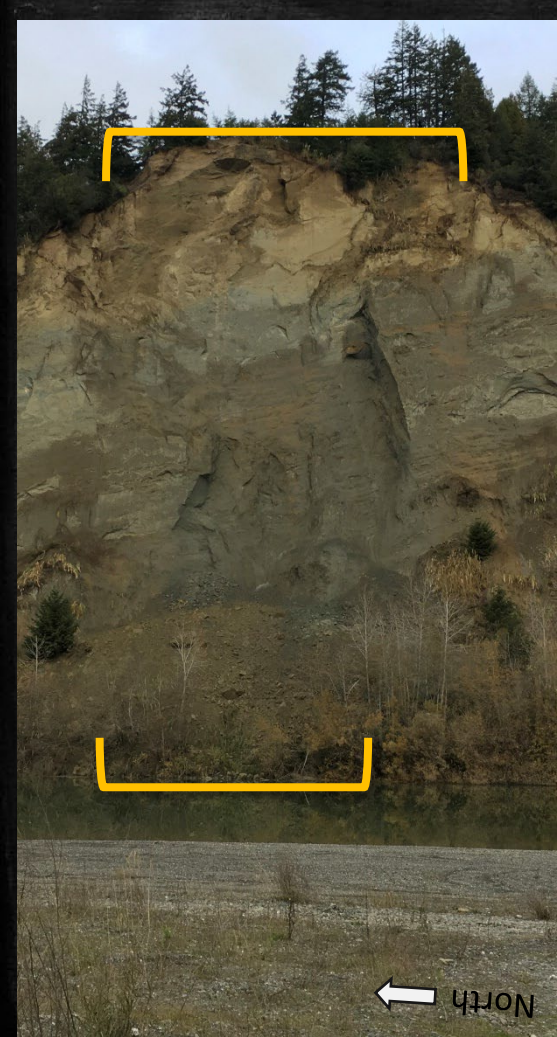
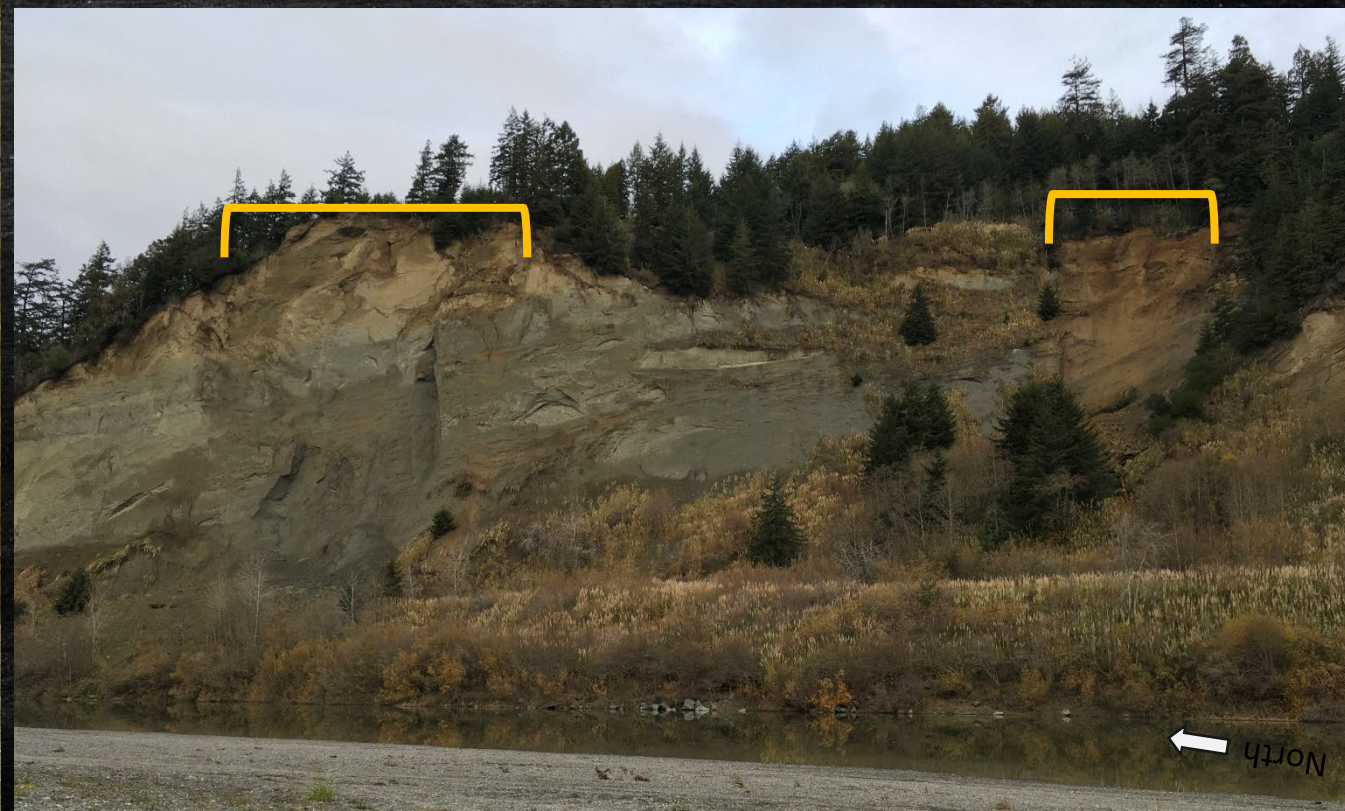
Scotia Bluffs
Cliff failures/rock topples

Nearby stations recorded PGAs ranging from 1.36g – 1.46g

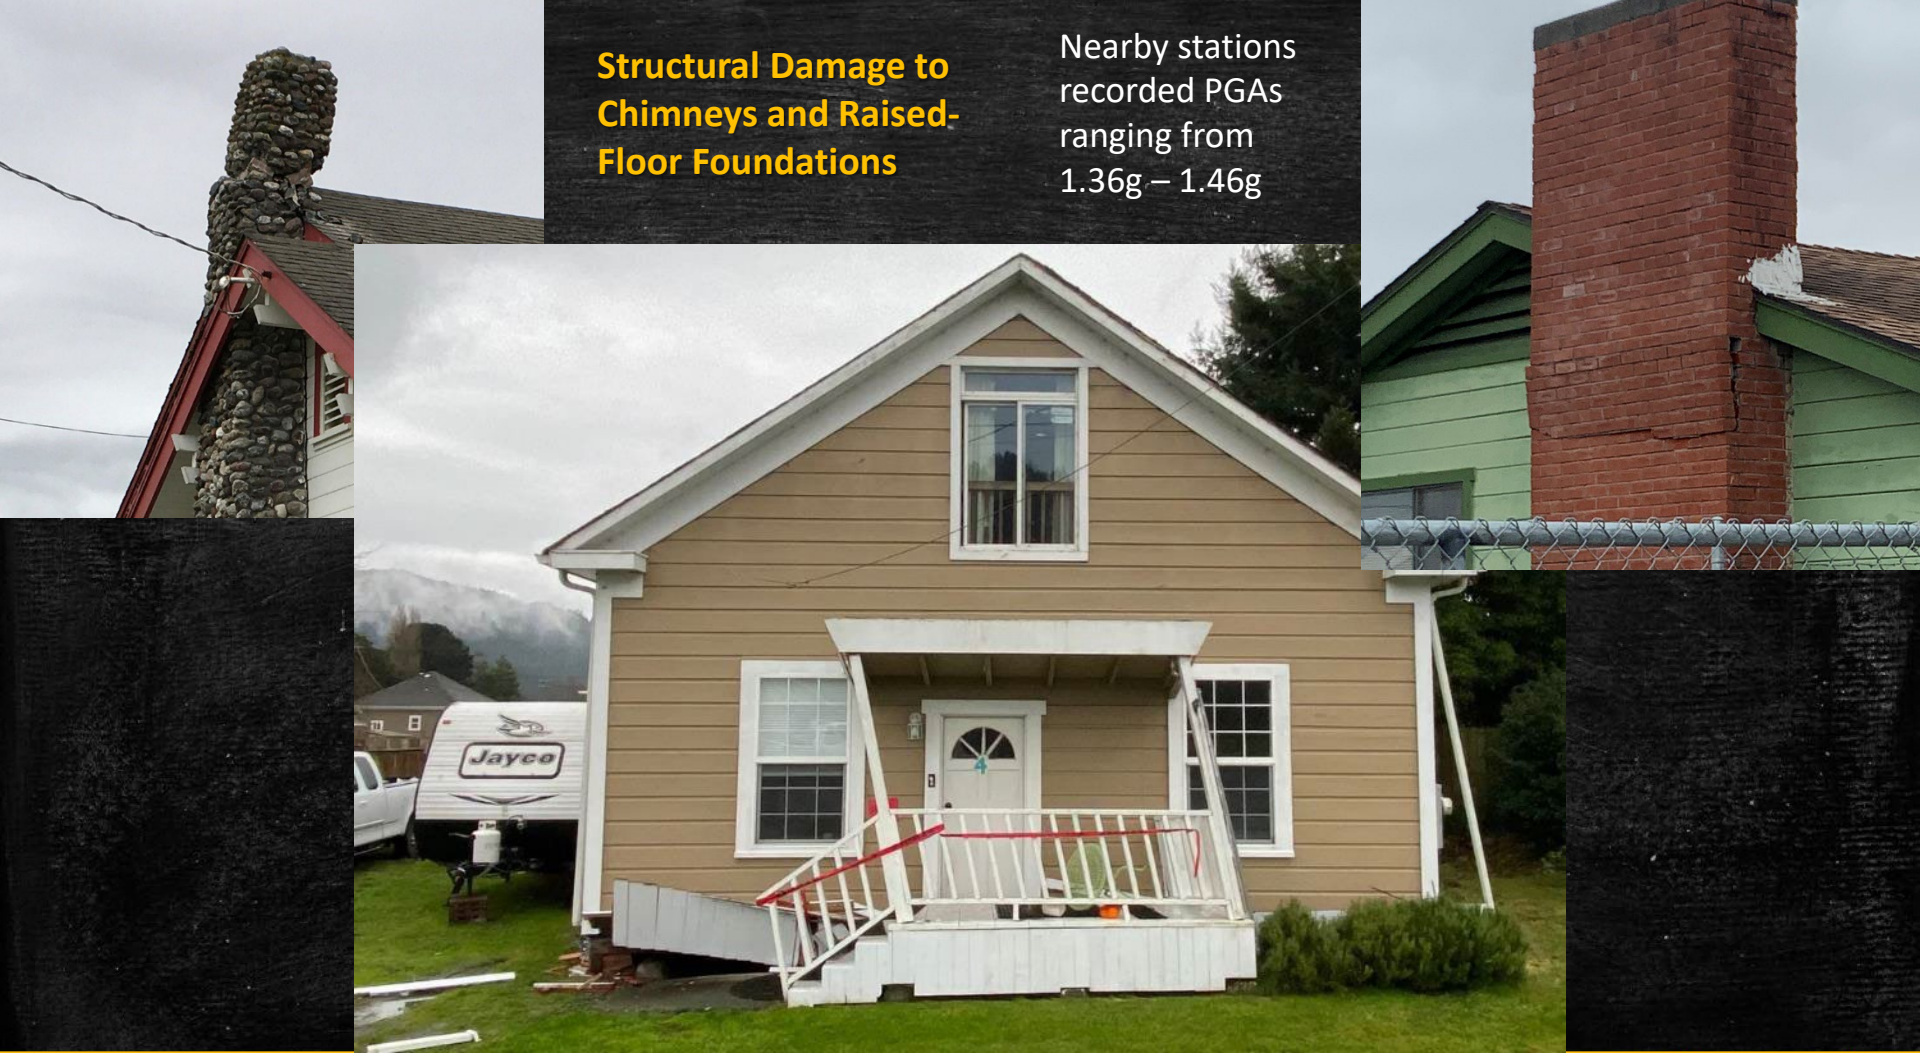
Structural Damage to Chimneys and Raised-Floor Foundations

Nearby stations recorded PGAs ranging from 1.36g – 1.46g

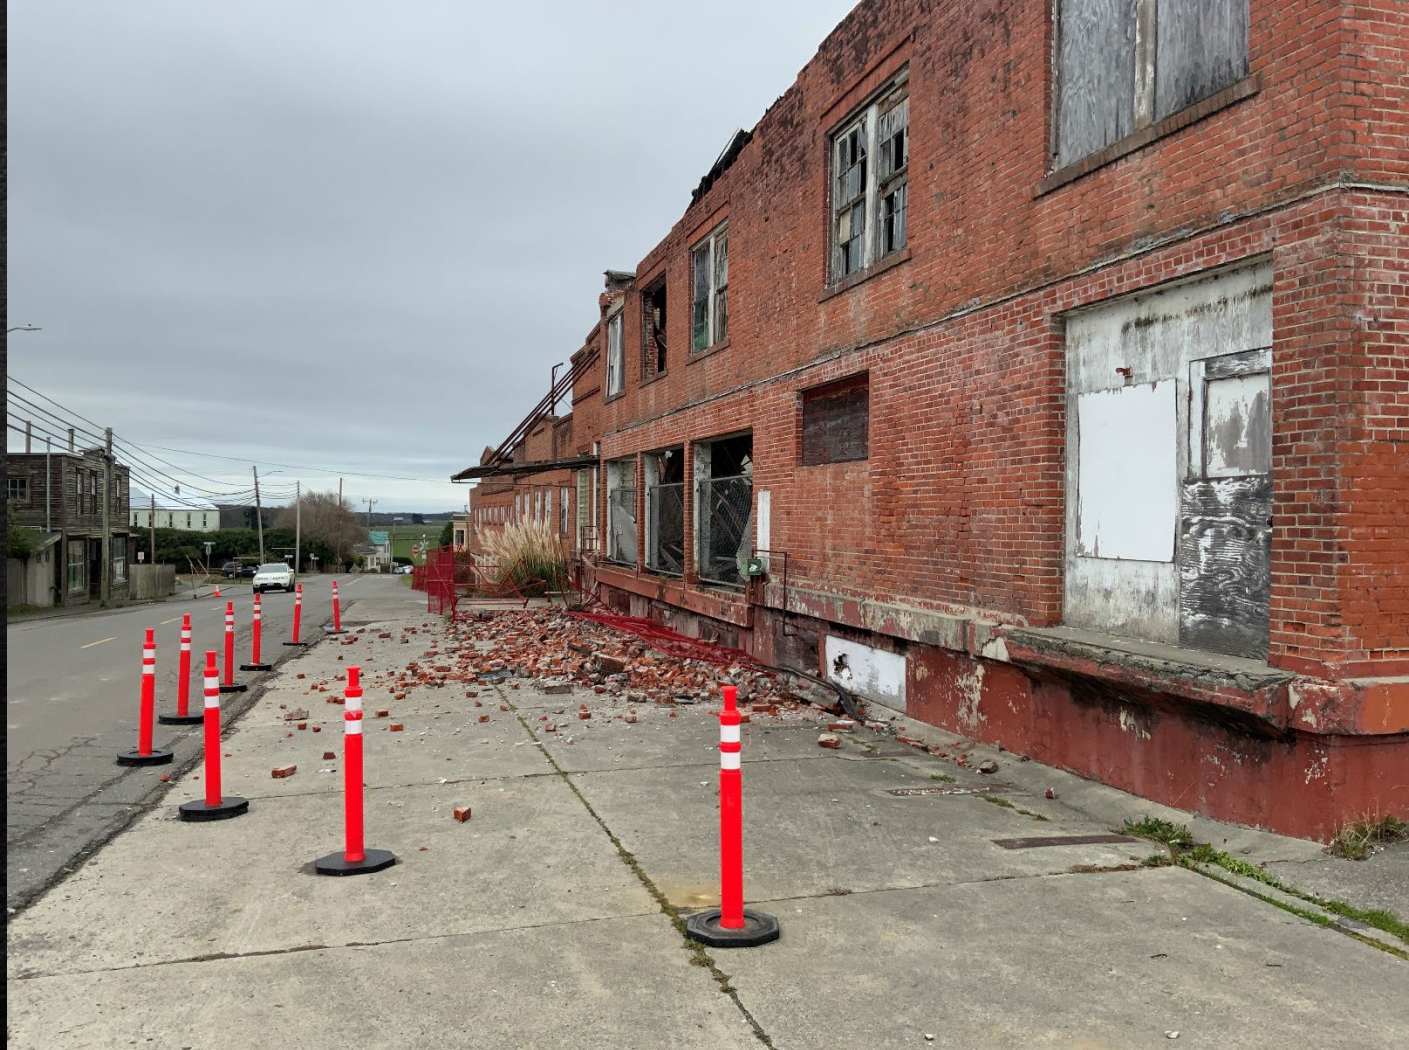
**Structural Damage to
Unreinforced
Masonry Buildings
(Loleta Creamery)**

Built 1893

Closed 2010

Torn down 2023

Nearby stations
recorded PGAs
ranging from
1.36g – 1.46g

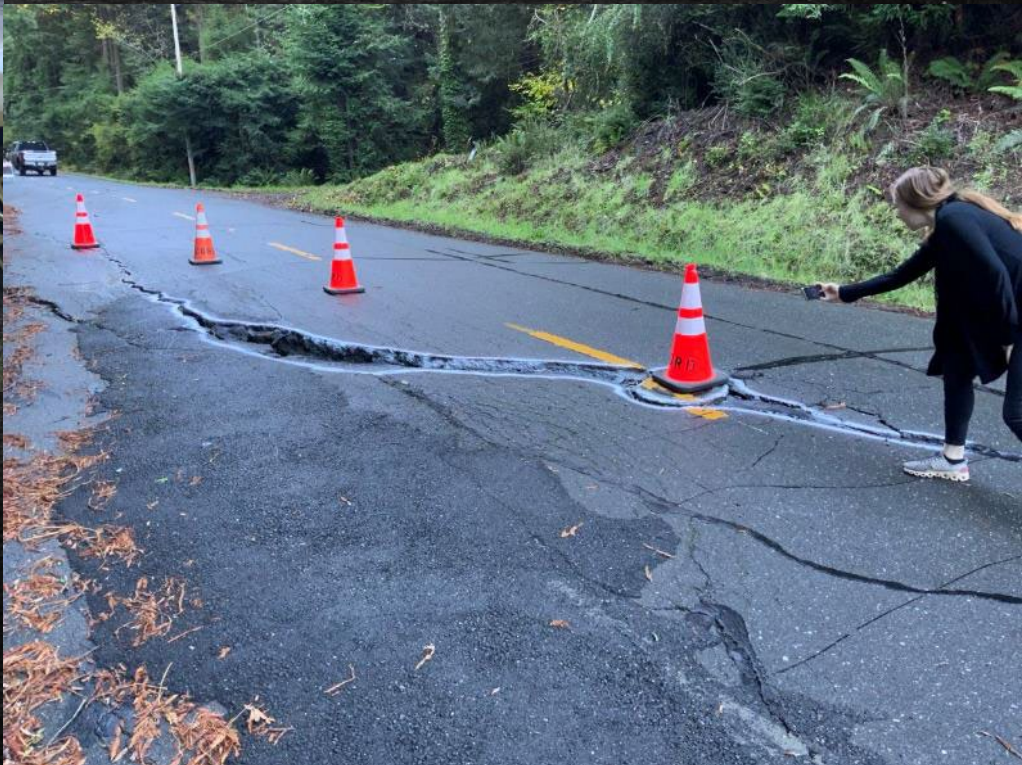
**Shivley Road
(south of Rio Dell)
Road shoulder
landslides**

Nearby stations
recorded PGAs ranging
from 0.13g – 0.17g

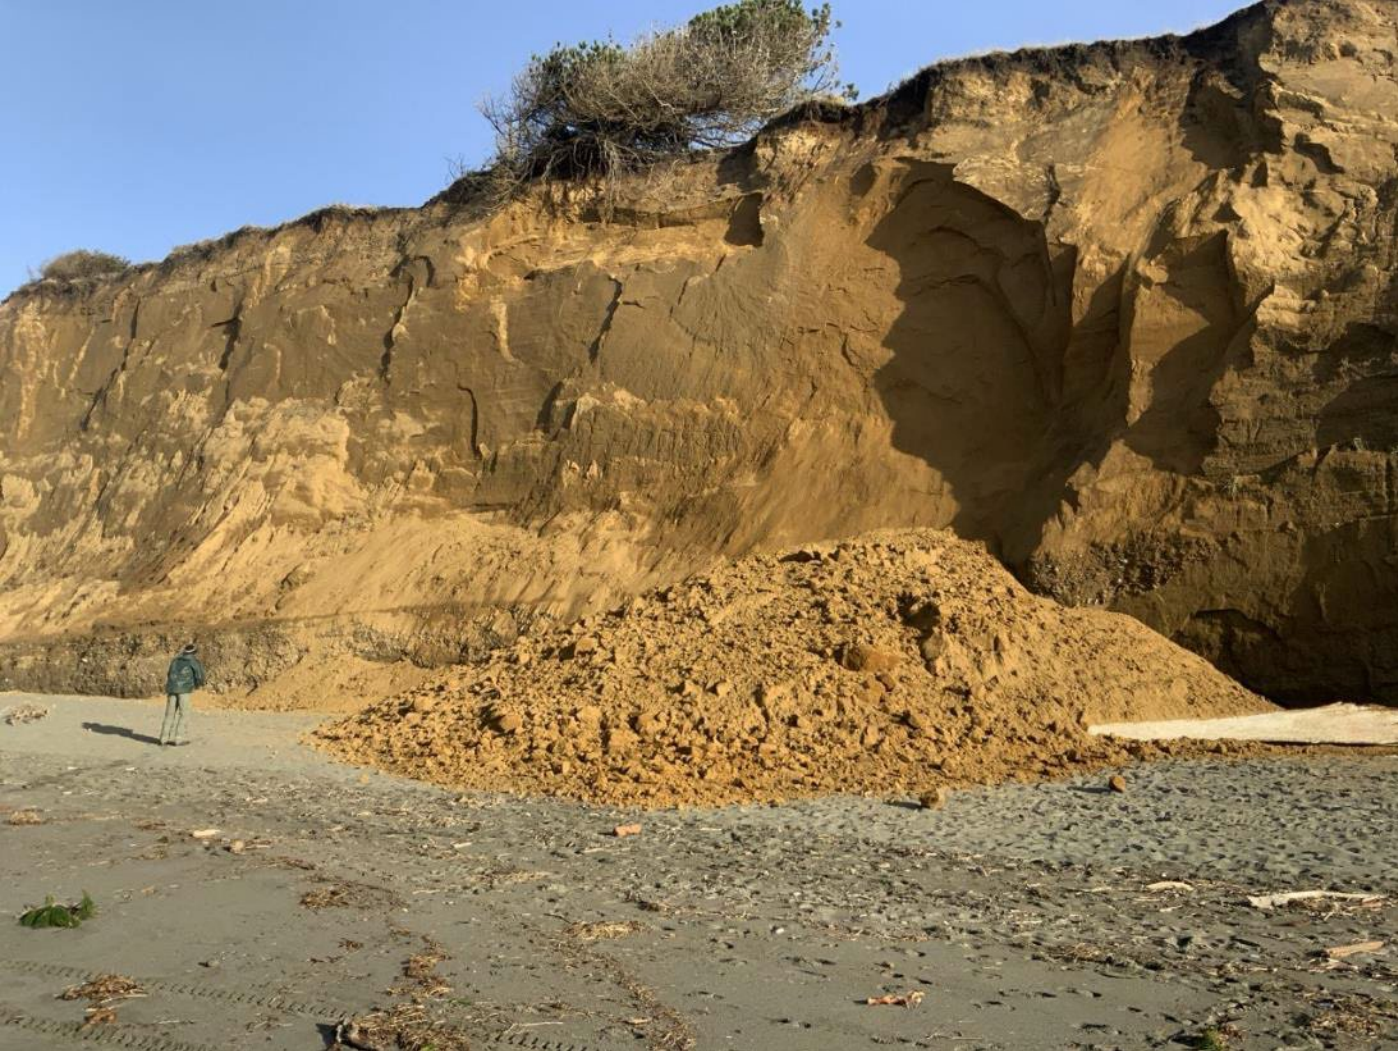
**Lost Coast headlands
(Bluff failure onto
the beach)**

Nearby stations
recorded PGAs of
about 0.48g
