Coseismic Landslide Patterns in Three Subduction Earthquakes: Field Observations and Cascadia Implications

Joe Wartman

Professor of Civil and Environmental Engineering, Univ. of Washington
Director, RAPID Facility

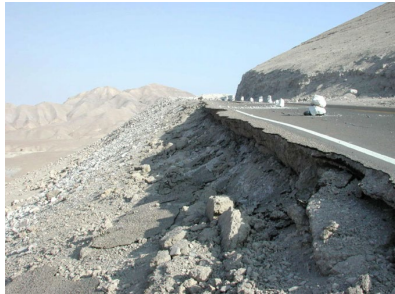
"The types of landslides and types of materials that produced landslides in this earthquake are similar to those of the vast majority of other earthquakes worldwide (Keefer 1984). However, two observations stand out as differing from the general pattern observed in other earthquakes:

- "First, the lack of large landslides throughout most of the region ... is unusual for an earthquake of this magnitude that affects a region where steep slopes are so prevalent."
- "Second, the widespread collapse of quebrada banks in the area ... is unusual in its severity."
- *Why? Extremely dry conditions, and Anomalously low seismic shaking*

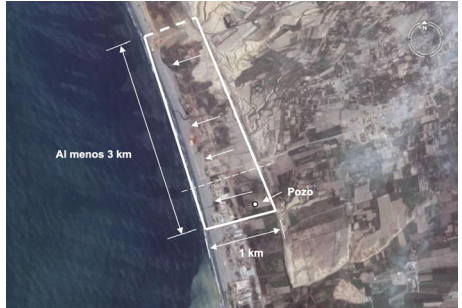
Journal paper highlights extremely large, lateral spreads and poor performance of cut slopes along roads.

- Three landslide settings

1. **Paracas Peninsula:** young marine sedimentary rocks, massive coastal losses
2. **Coastal Plains:** dominant ground failures were liquefaction and lateral spreading
3. **Andes Mountains:** Range of landslide types

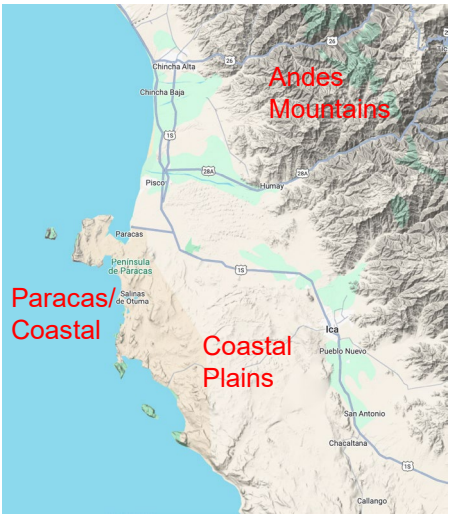
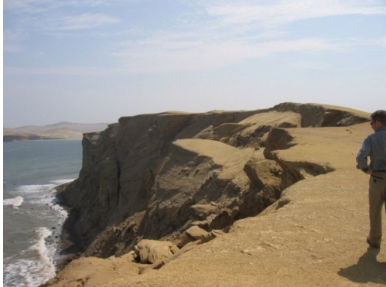
- Significant large failures along the coast and comparatively few failures inland

- Inverse relationship found between PGA and landslide intensity in parts of the Andes Mountains

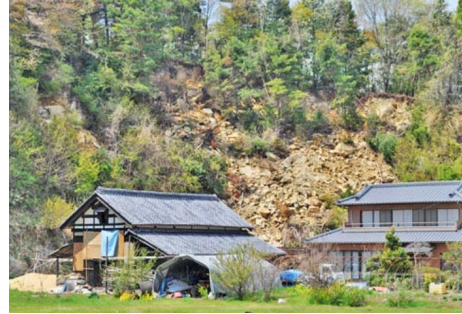
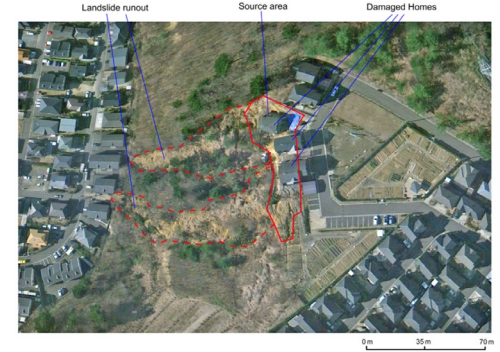
- Lack of Correlation Between Landslide Intensity and Ground Motion: Found no correlation between landslide intensity and PGA.
- Other factors, such as the geologic unit, might have exerted a stronger influence on landsliding than ground shaking intensity.

- Unexpected Landslide Distribution: Despite experiencing high ground motions and having rugged terrain, the Kitakami and Abukuma Mountains had surprisingly few landslides. Conversely, the low-relief plain regions experienced a higher-than-expected level of landslide erosion.
