CGS Post-Earthquake Field Data Collection for the 2022 Ferndale & 2024 Cape Mendocino Earthquakes, Humboldt County, California

Brian Olson
Senior Engineering Geologist
California Geological Survey

Cascading Hazards Workshop
March 7, 2025 – Newport, OR

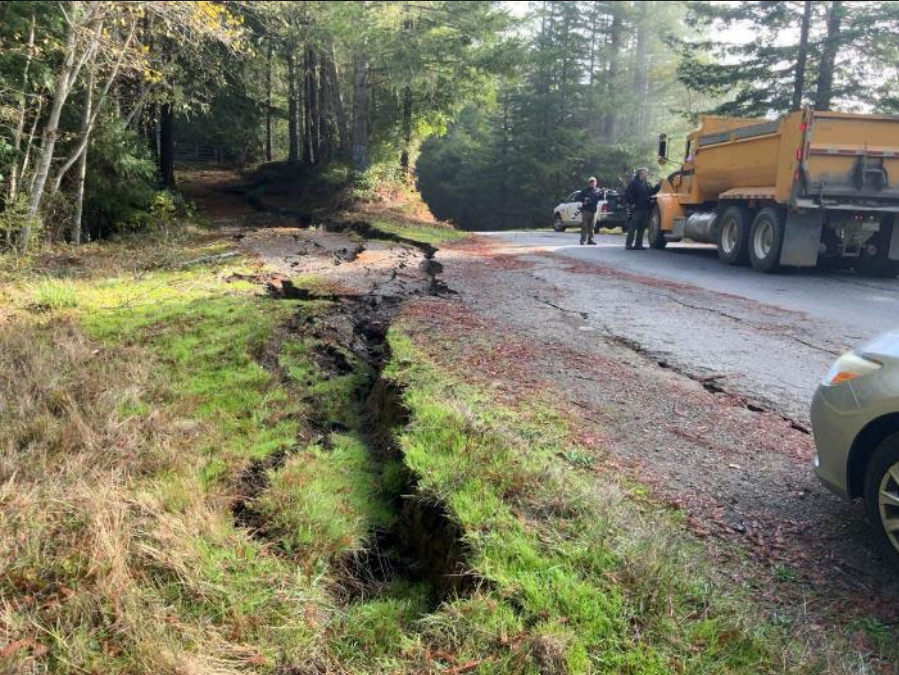
Nearby station
recorded PGAs of
about 0.24g

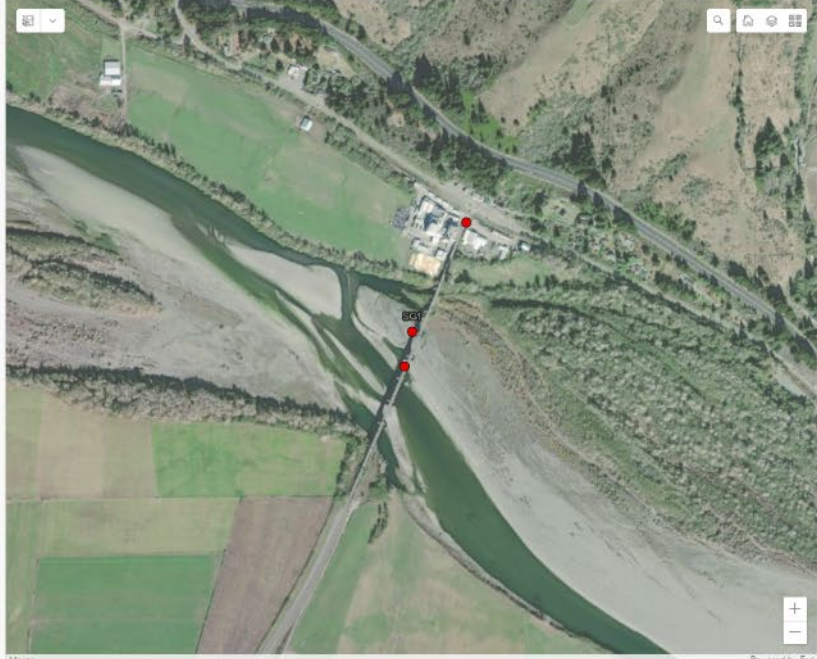
Point Observations: SG1

Adjacent Features	
Date of Movement (YYYYMMDD,Time)	
Depth	
Diameter (m)	
Displacement Amount	
Estimate Direction of Slope Movement	
Estimated Max Drop in Elevation (ft)	
Estimated Maximum Vertical Movement (m)	
Facility Affected	Bridge
Facility Cause of Damage	Shaking
Facility Damage Severity	Severe (Red Tag)
Fault Slip	
Feature_Origin	Damage
Heave (cm)	
Heave_Max(cm)	
Heave_Min(cm)	
Height of material (m)	
Horizontal Separation Max (cm)	
Horizontal Separation Min (cm)	
Horizontal Separation (cm)	
Landslide Feature	
Length Exposed Downslope	
Liquefaction Area Affected (sq. meters)	
Liquefaction Facility affected	
Local Fault Azimuth (0.360°)	
Local Fault Dip (0.00° Right hand rule)	
Material Type	
Net Slip Max (cm)	
Net Slip Min (cm)	
Net Slip Preferred (cm)	
No Deformation Comments	
Notes	Fermbidge
Observational Accuracy
